CASE STUDY

Location: University of Colorado - Boulder, Colorado
Application: Folsom Field Stair Tread Repairs
Product: Fiberplate® Stair Tread Covers

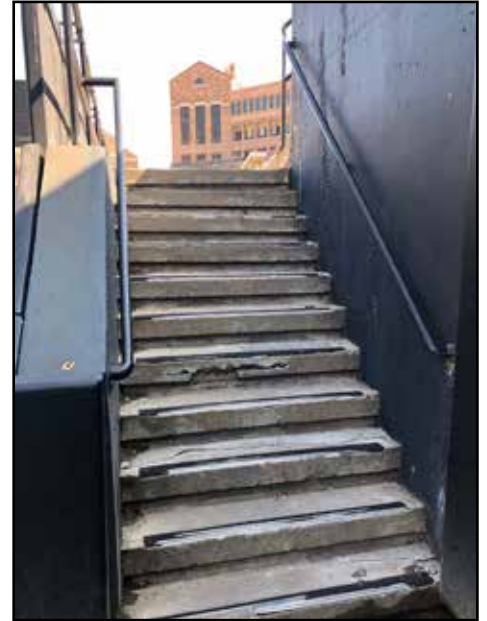
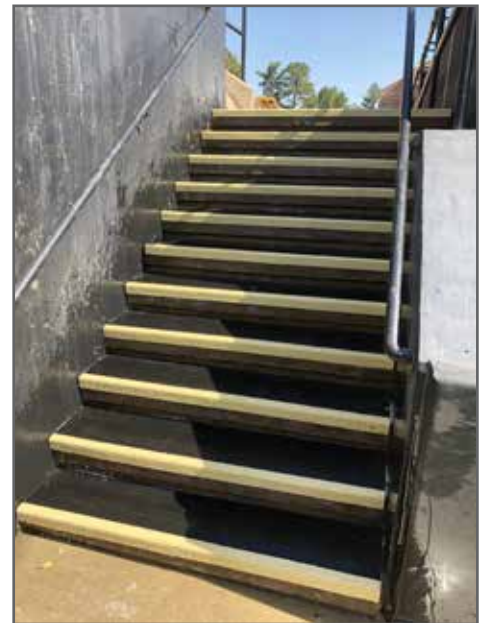
After having to repair the stairs every two years, this application needed to be low maintenance and provide long service life. This is why the Fiberplate Stair Tread Covers were the perfect candidate for this project. These tread covers provide solid, slip resistant footing for existing treads that are still structurally sound, helping the client save time and money in the installation process and maintenance.

The standard color is dark gray with a highly visible safety yellow nosing; however, since this football field is the house of the "Bufs," the tread covers were ordered in CU Buffaloes logo colors, black and gold. The client is very happy with the installation not only because of the quality and corrosion resistance of our product but also Fibergrate's sales representative supervised and participated in the installation of these Fiberplate Stair Tread Covers, backing up the quality of our products with the customer service we deliver in every project. Repairs every two years will no longer be necessary for this client which is why Fibergrate is ready to participate in the bidding to cover all of the stair treads in the stadium.

Frequently exposed to very cold, dry, and windy winters, the concrete stairs at the Folsom Field suffered from corrosion due to freeze. Concrete is porous, so whenever it rains or snows, the water percolates through the concrete. This causes the concrete to break when the water freezes. Needless to say, repairs were being made every two years.
