Shower Room

Project Specs

Application: Shower Drain Covers

Product: Aqua Grate® Pultruded Grating

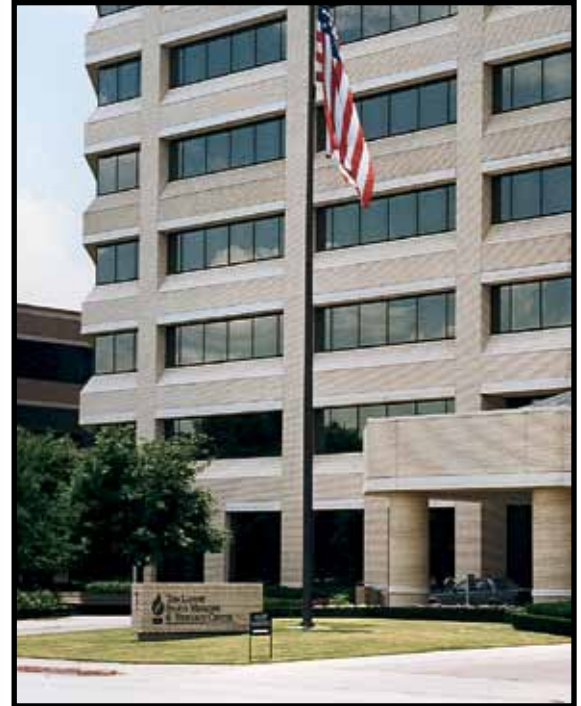
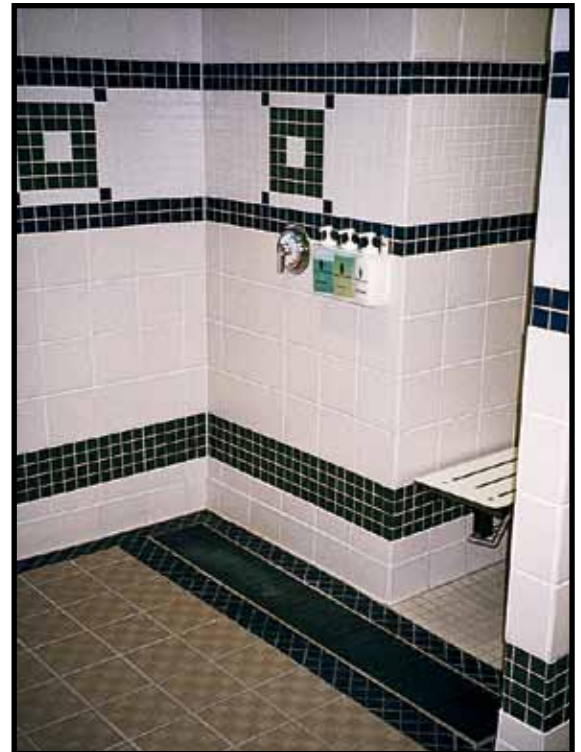
The facility chose Fibergrate's Aqua Grate® pultruded pedestrian grating to cover the drains in their training center locker rooms. The drains varied in length and were approximately 10" in width. Because the drains were narrow in width, 6" tie bar spacing was used for the 1" deep pultruded grating. The Aqua Grate® T1210 grating with its standard silica sand grit provides a safe, slip-resistant surface, yet is gentle on the players' feet.

The gray, built-in color also blends well with the shower walls and floor and will not require future painting by the maintenance crew. Because Fibergrate offers corrosion resistant products, they won't have to worry about scraping corroded grating either. Let Fibergrate Composite Structures solve your flooring or structural requirements.
